Gowanus Canal Proposed Plan **Question/Answer Sessions** Community Advisory Group Meeting February 11, 2013 Red Hook Meeting February 13, 2013

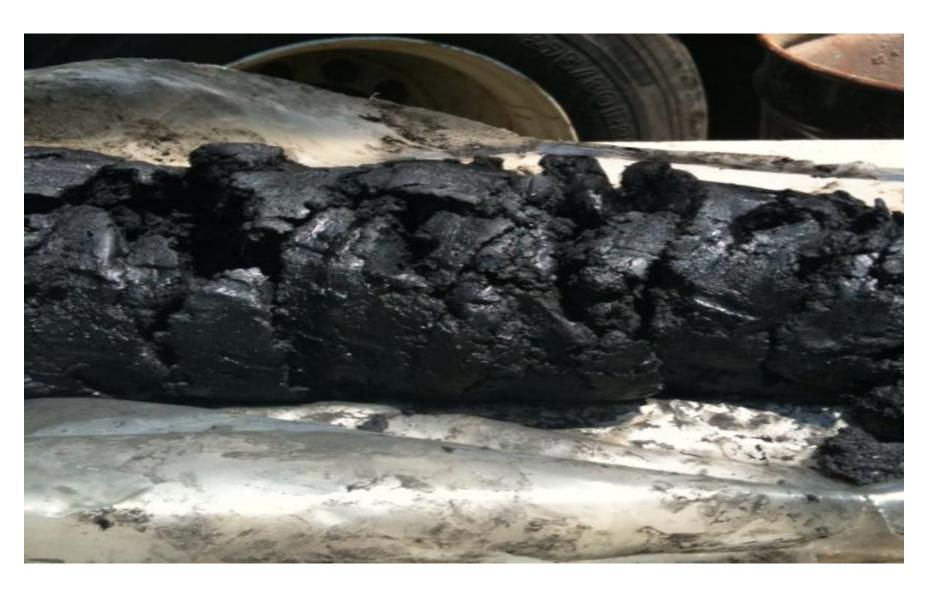
Core from 1st Street Basin

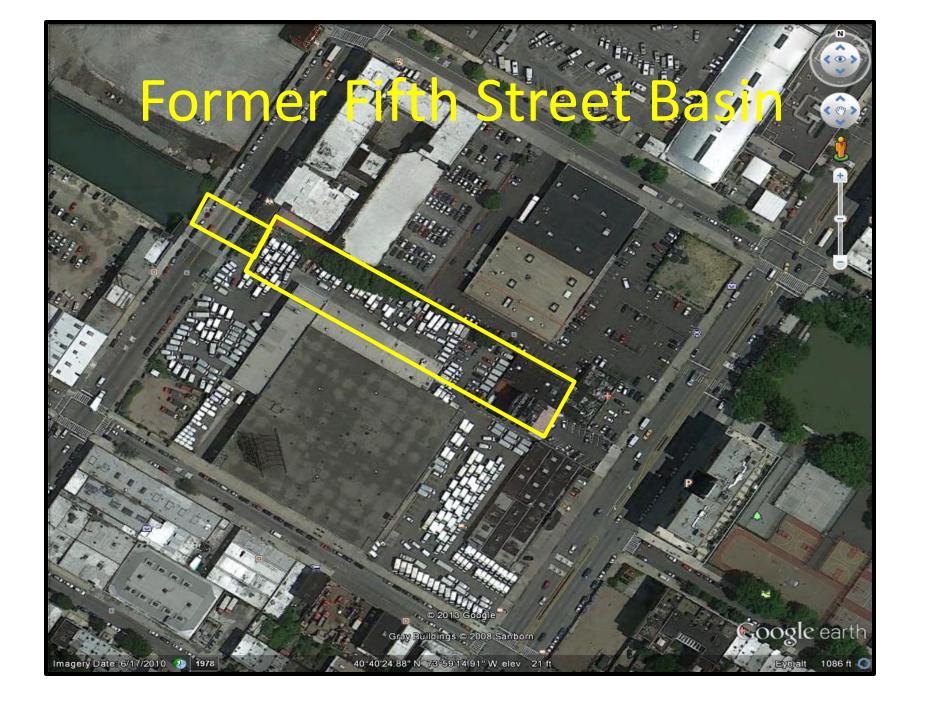
5th Street Basin - filled between 1953-1964. (Looking east from Canal below 3rd Ave. Bridge towards 4th Avenue.)

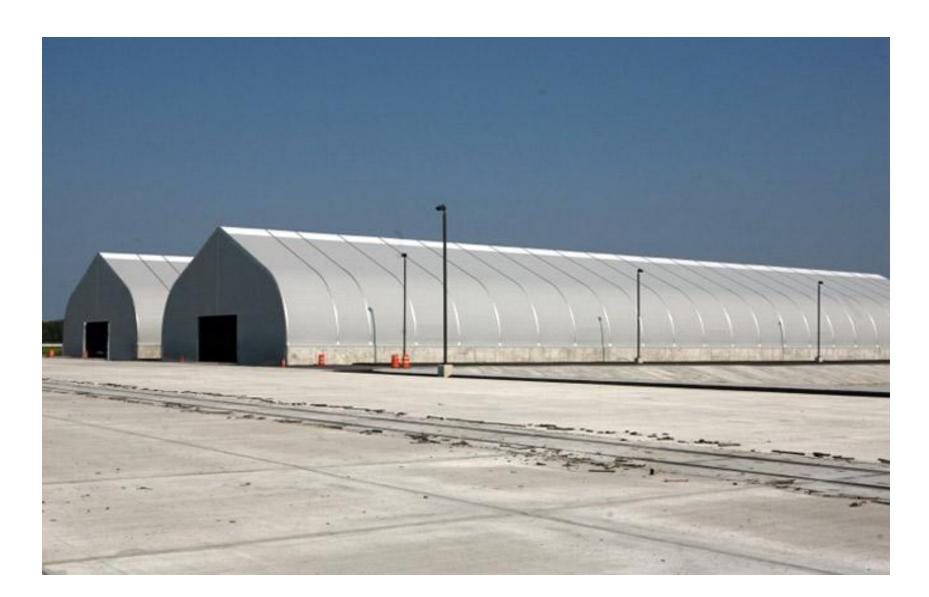
Enclosed Work Structures

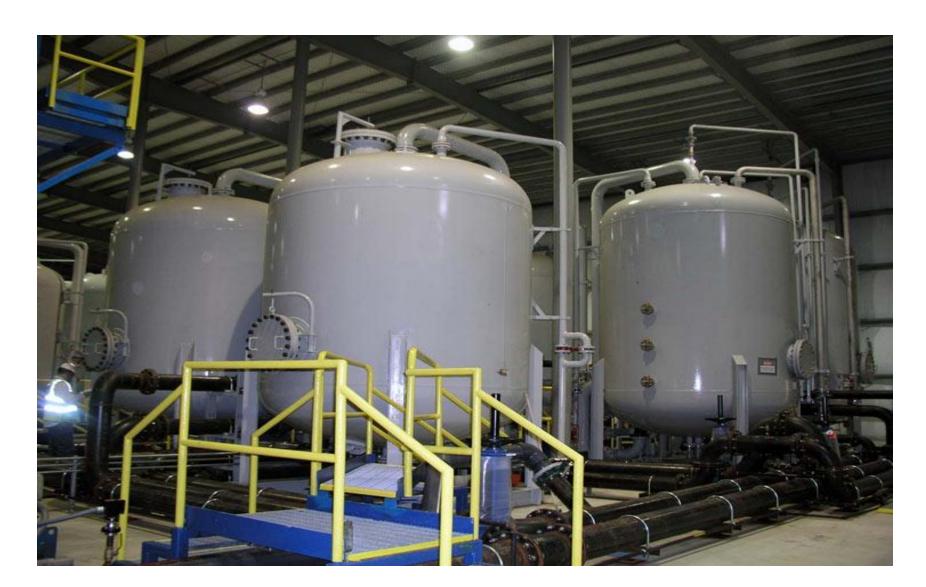
Water Treatment System

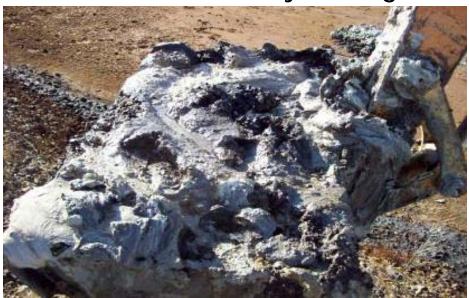
Laboratory Testing of Process Application

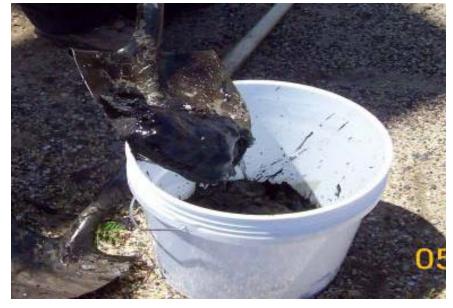
Untreated Sample in the Field

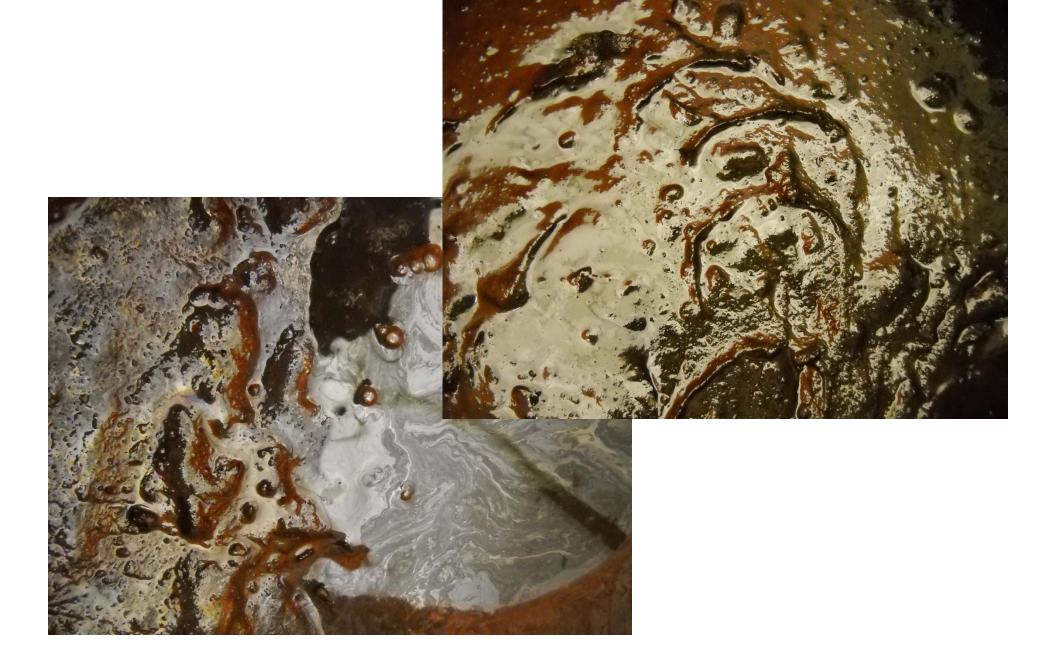
Gowanus Sediment Samples Collected for Laboratory Testing

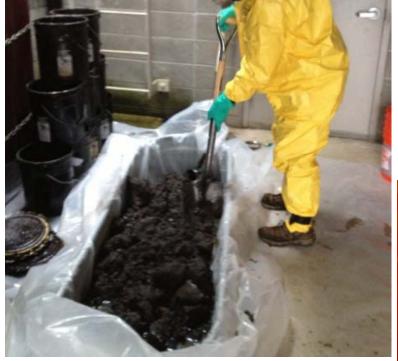
Sediment sample collected from canal and mixed

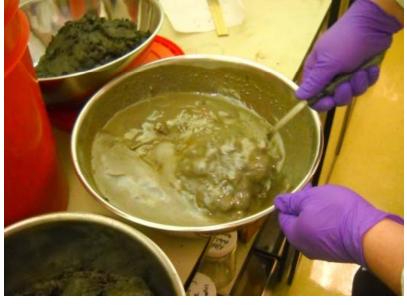
Cement agents and adsorbents mixed into a slurry

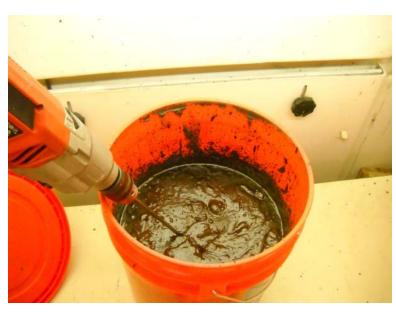
Cement agents and adsorbents mixed with sediment

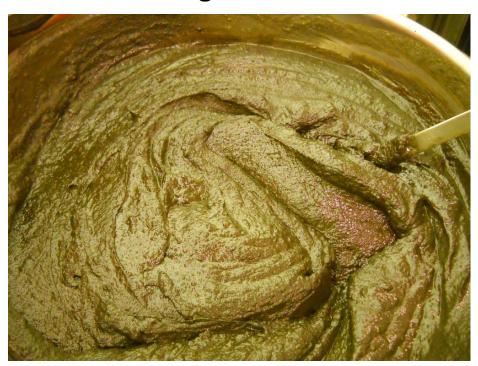
Untreated sediment being mixed

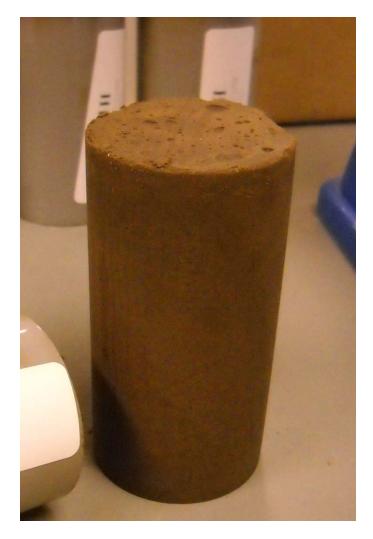
Stabilized sediment material

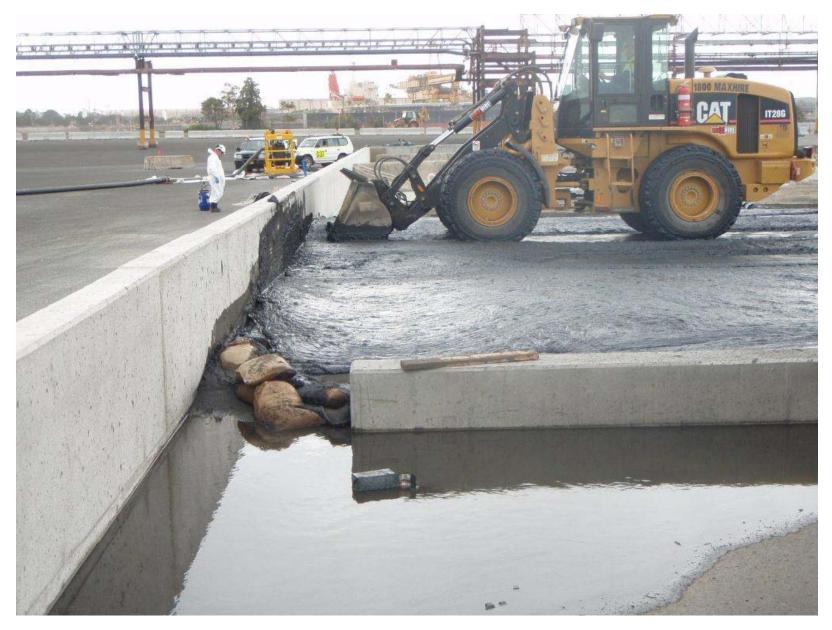
Stabilization Example-Sediment Drying Bed

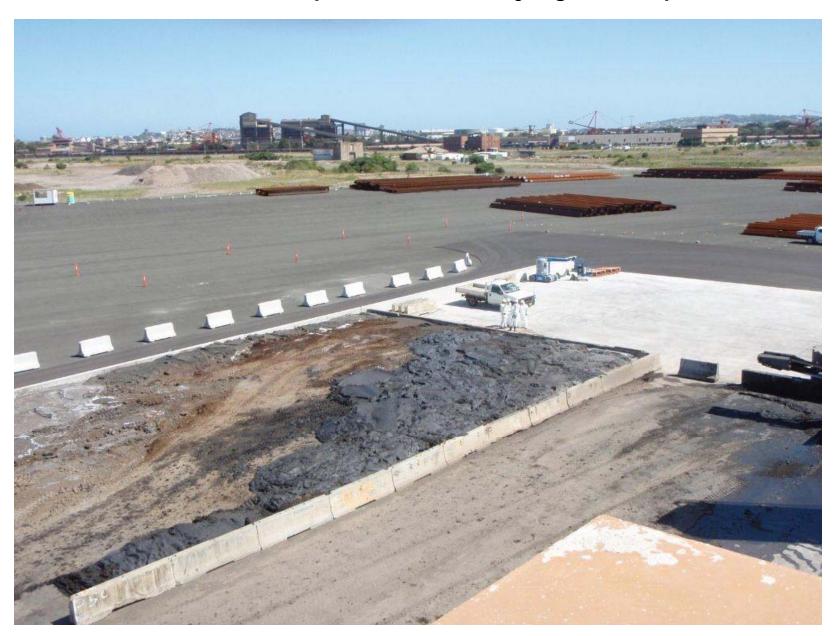
Stabilization Example-Sediment Drying Bed Top View

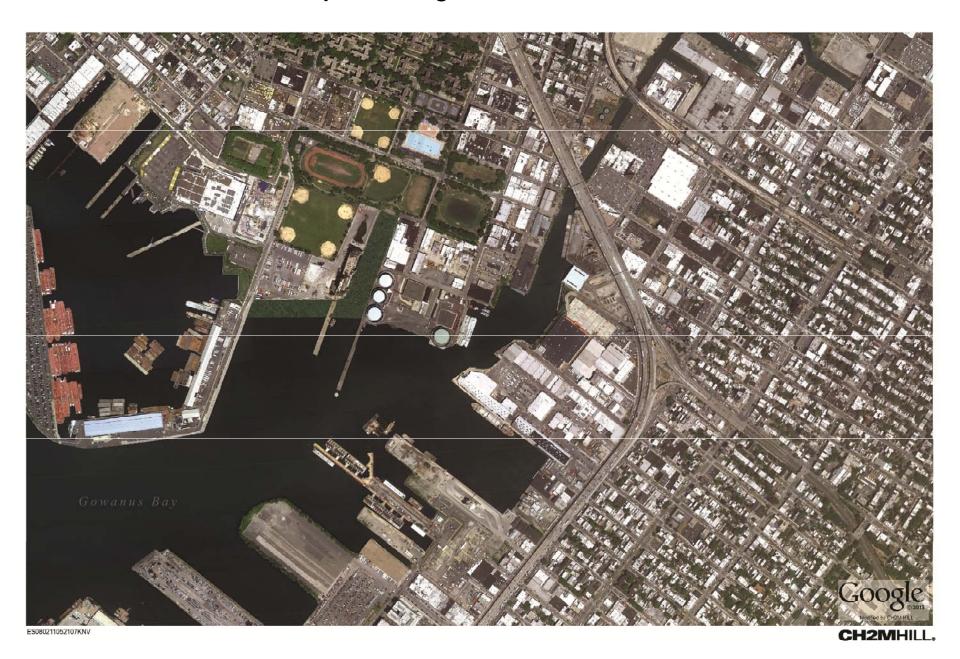
Conceptual Diagram of Potential CDF

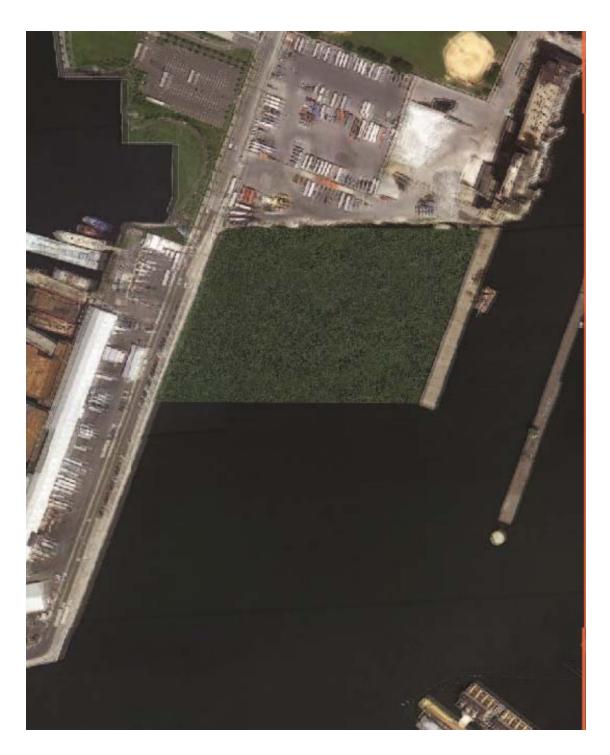
Conceptual Diagram of Potential CDF

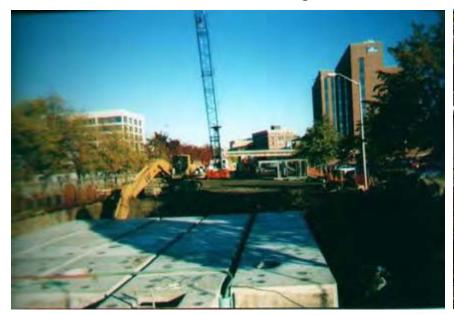
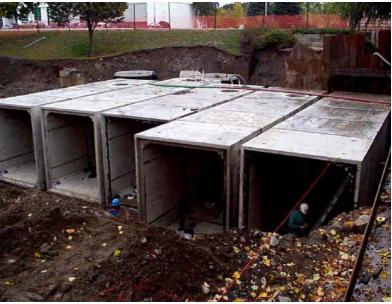
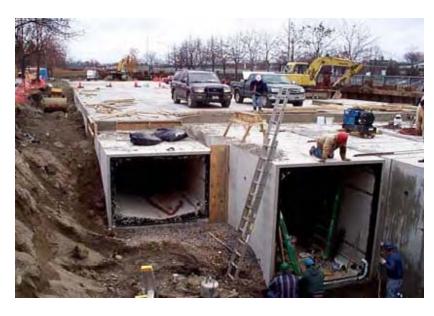
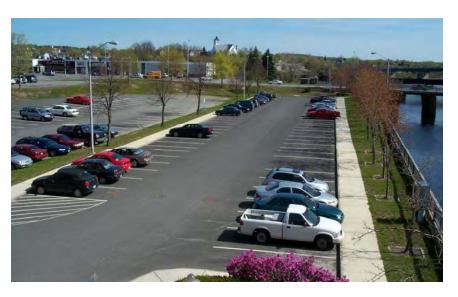
Bangor, ME – Kenduskeag East Tank

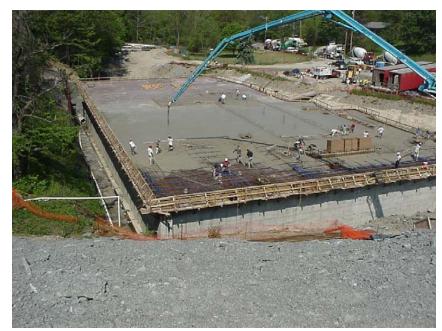
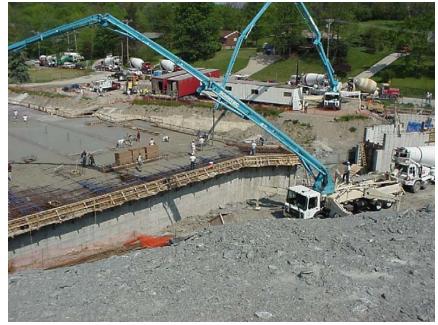
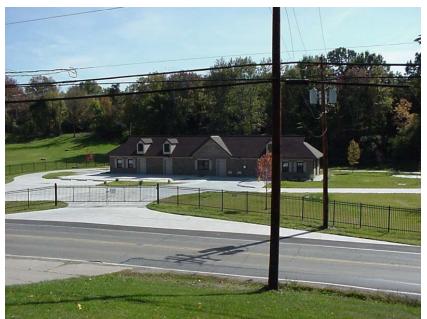
Cincinnati: Muddy-Westbourne CSO No. 198

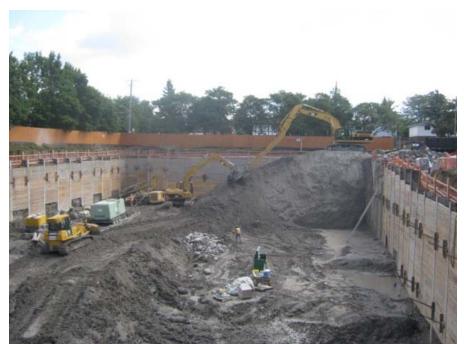
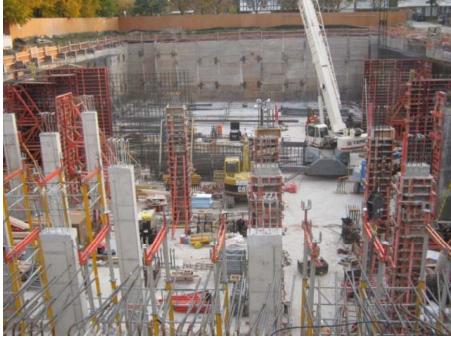
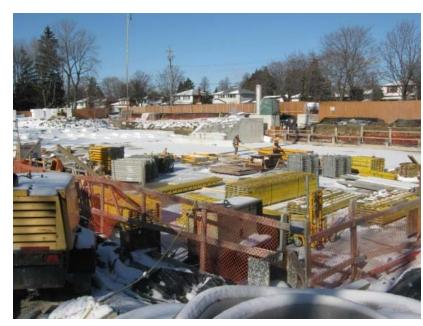
Toronto - Old Sheppard Storm Storage Tank

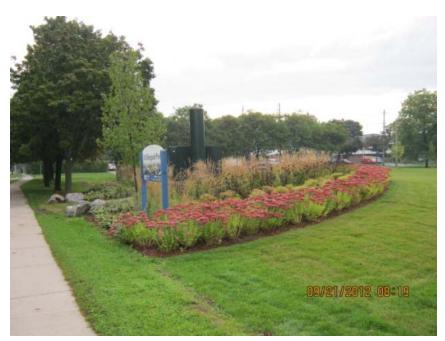
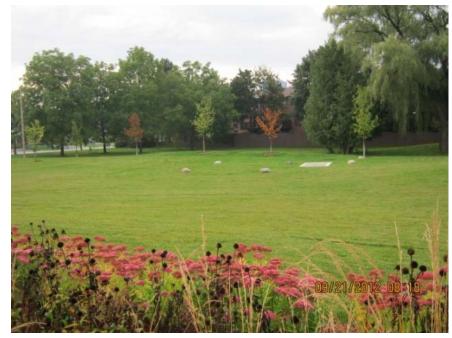
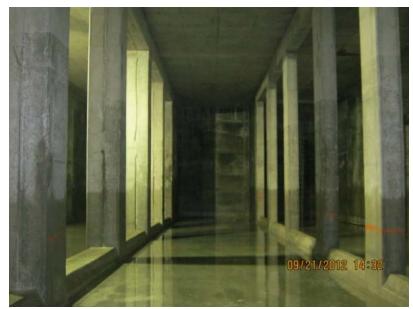
Toronto - Old Sheppard Storm Storage Tank -contd
